1 **AMBIENT VIBRATIONS OF AGE-OLD MASONRY TOWERS: RESULTS OF LONG-**  
2 **TERM DYNAMIC MONITORING IN THE HISTORIC CENTRE OF LUCCA.**

14 **Abstract**

15 The paper presents the results of an ambient vibration monitoring campaign conducted on so-called  
16 “Clock Tower” (Torre delle Ore), one of the best known and most visited monuments in the historic  
17 centre of Lucca.

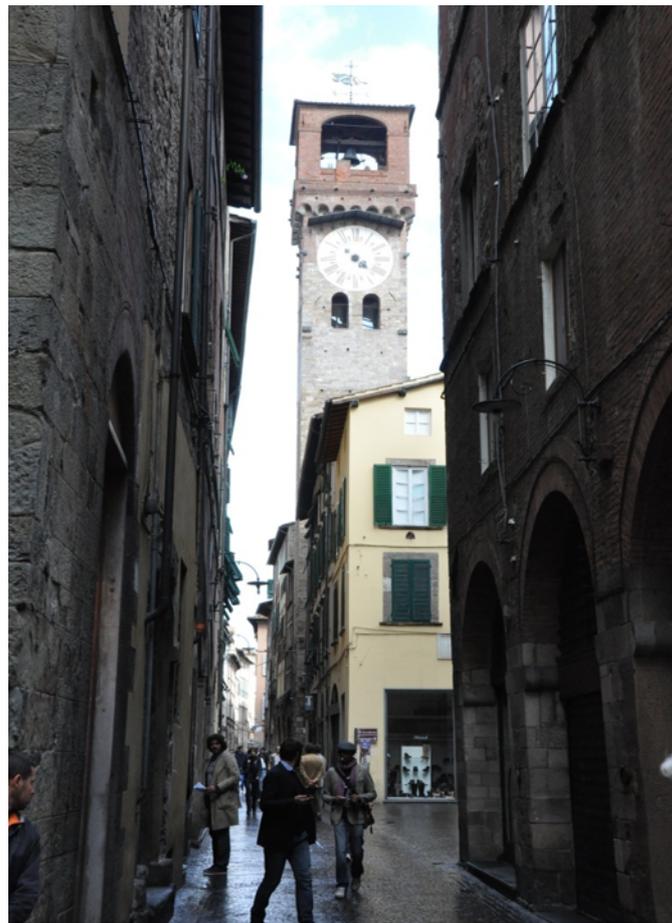
Figure 2. The Clock Tower: view from Via Fillungo.

95 Lucca was renowned in the past for the large number of towers in its skyline: of more than one  
96 hundred during Middle Ages, only ten or so of these fascinating monuments have survived until  
97 today (Figure 1). The Clock Tower is one of the best known and most visited age-old towers in  
98 Lucca, thanks to the peculiar shape of its bell chamber, which is clearly visible and recognizable  
99 throughout the entire historic centre. Built by local families (Concioni 1988), since the last decade  
100 of the 15<sup>th</sup> century the Clock Tower has been used as a civic building, taking its name from the big  
101 clock visible on its southern facade (Figure 2). The Clock Tower rises at the corner between the  
102 roads named Via Arancio and Via Fillungo, one of the most popular in Lucca's historic centre; the  
103 adjacent buildings abut the tower on two sides for a height of about 13 m and constitute asymmetric

104 boundary conditions for the tower's structure. The Clock Tower is 48.4 m high at the top of the bell  
105 chamber; it has a rectangular cross section of about 5.1 x 7.1 m and walls of thickness varying from  
106 about 1.77 m at the base to 0.85 m at the top. Two barrel vaults are set inside the tower at heights of  
107 about 12.5 and 42.3 m. The bell chamber, made up of four masonry pillars connected by elliptical

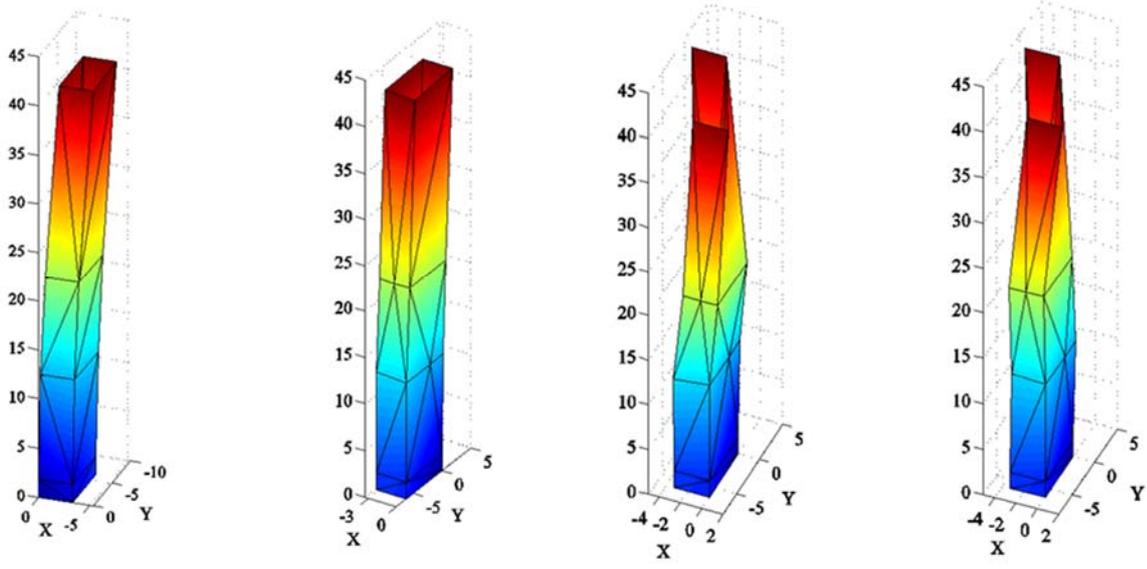
The tower's first four mode shapes.

113 On 25 November 2016, during a preliminary experimental campaign, the response of the Clock  
114 Tower to ambient vibrations was monitored for a few hours via four SARA SS20 three-axial  
115 seismometric stations. The instruments were moved along the tower's height by adopting three  
116 different layouts and combining data in order to identify four natural vibration frequencies and  
117 mode shapes of the tower, as described in (Pellegrini et al. 2017). Data collected in this experiment  
118 also allowed evaluating the mechanical properties of the tower's constituent materials via model  
119 updating procedures, as described in (Girardi et al. 2019). Table 1 summarizes the frequencies  
120 calculated in the preliminary campaign of November 2016 (Pellegrini et al. 2017). The mode shapes  
121 of the tower corresponding to the first four frequencies determined by taking advantage of the

122 different layouts used for mapping the tower's vibrations, are shown in Figure 3. The first two  
123 frequencies refer to bending modes along the  $x$  (first) and  $y$  (second) directions, while the third is a  
124 torsional mode and the fourth is a torsional-bending mode involving movements of the structure's  
125 upper parts. Since the tower is located in the historic centre, in a limited traffic area, the  
126 environmental vibrations are quite low and do not allow to estimate frequencies and mode shapes  
127 higher than the fourth.

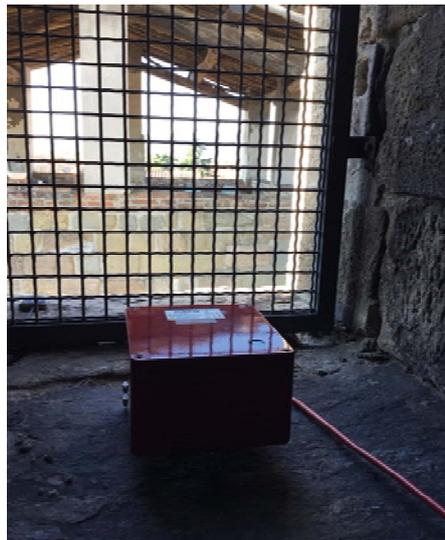
Figure 4. Sensor S.943 at level +24 m inside the tower.

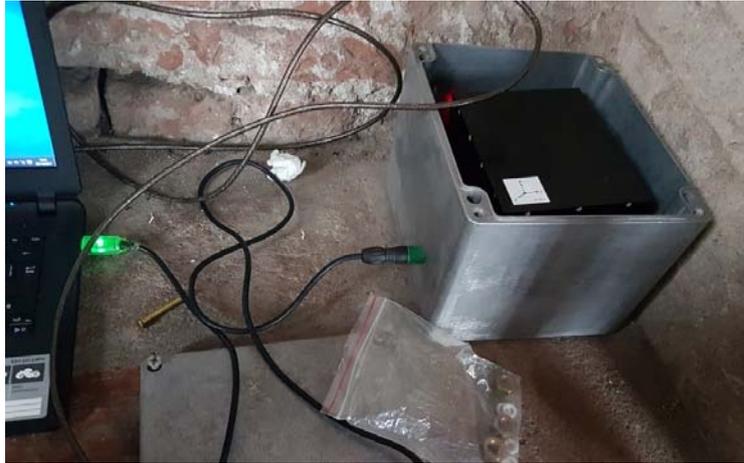
Figure 5. Sensor S.2 at level +37 m inside the tower.

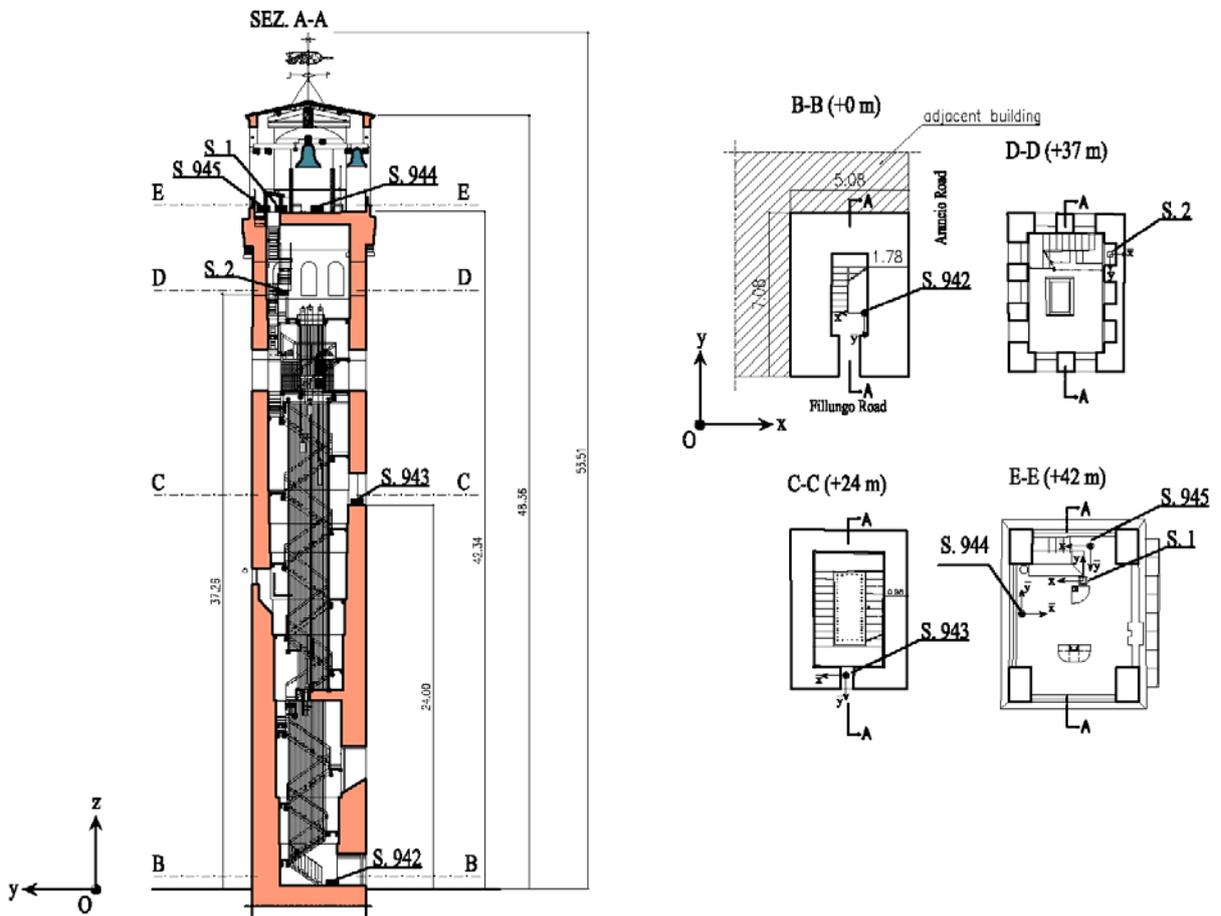
495 Figure 6. Sensor arrangement on the Clock Tower: sensors S.942, S.943, S.944, S.945 (SARA), sensors S.1, S.2 (AGI).

145 The instrumentation was kept running on the tower up to March 2018. Figure 6 shows the layout of  
146 the sensors along the tower during the experiment: seismic station S.942 was placed at the base,  
147 collecting data from the ground, S.943 was at the height of 24 m above street level, the remaining  
148 two stations S.943 and S.944 were placed on the bell chamber, at about +42 m above street level.  
149 The AGI stations were both installed in the upper part of the structure, S.2 at +37 m and S.1 on the  
150 bell chamber level.

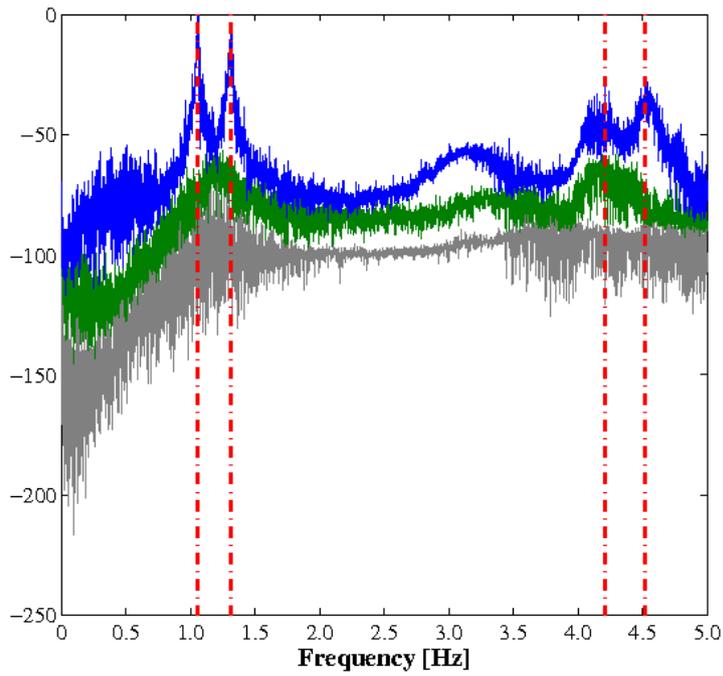
Figure 7. The three eigenvalues of the matrix  $H[j\omega]^H H[j\omega]$  vs. the frequency on a log-magnitude scale.

180 authors' opinion, it represents a natural frequency of the building next to the tower and does not  
181 belong to the tower structure itself. Such conclusion is confirmed by the CMIF analysis, shown in  
182 Figure 7, where the three eigenvalues of the matrix  $H[j\omega]^H H[j\omega]$  are reported vs. frequency, with  
183  $H[j\omega]$  the Frequency Response Function matrix of the system, estimated by the  $H_1$  estimator, (Maia  
184 and Silva, 1997) and  $\omega$  the circular frequency. Figure 7 refers to the analysis of a one-hour long

185 dataset recorded by the INGV seismic stations: the four peaks represent the identified four  
186 frequencies of the tower, the 3 Hz frequency being much less accentuated.

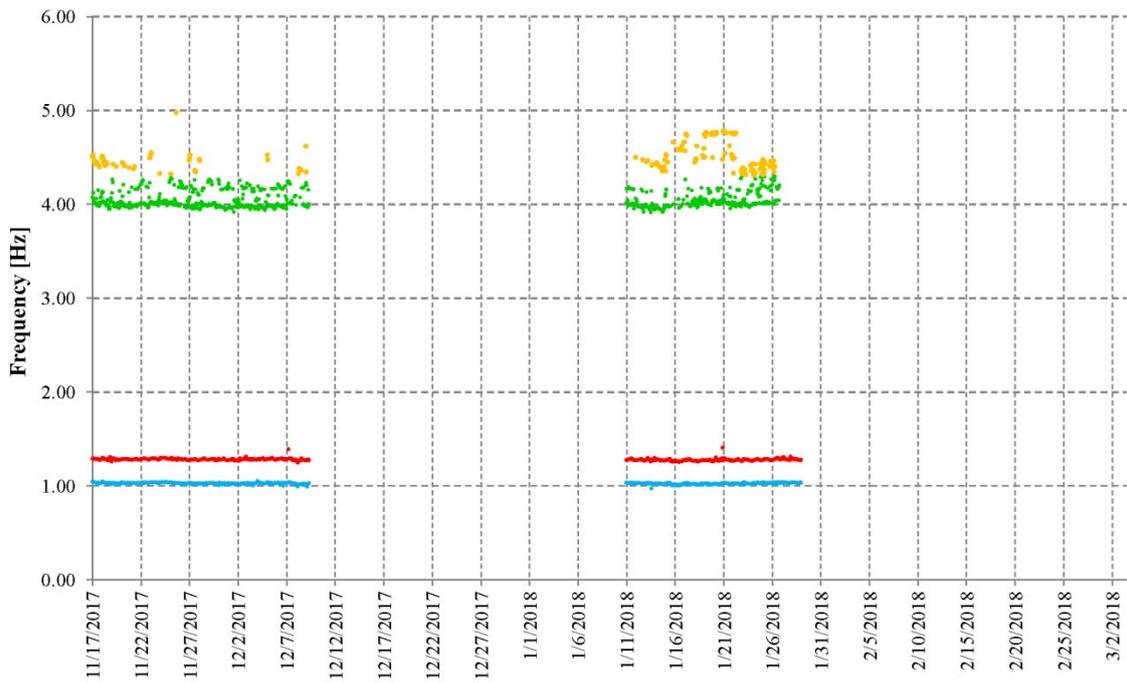
Figure 8. The tower's first four natural frequencies [Hz] detected by SS20 velocimeters during the monitoring period.

187 The tower's frequencies are reported in Table 2, where the mean values (evaluated over the entire  
188 monitoring period from November 2017 to March 2018) of the four frequencies are reported,  
189 together with their relative differences (evaluated on the 1<sup>st</sup> and 99<sup>th</sup> percentile) for the two different  
190 instruments. The frequencies values measured on the Clock Tower are in good agreement with  
191 those of other towers with similar geometries (Bartoli et al. 2017). The frequency values vs. time  
192 are reported in Figures 8 and 9 for the SS20 and the AGI instruments, respectively. The mean  
193 values evaluated by the two instruments are in very good agreement. The first and the second  
194 frequencies were detected by the two instruments in all records, and the variation in the two  
195 frequencies is on the order of 3%. This variation is also in good agreement with the findings of

196 another long-term dynamic monitoring conducted on the San Frediano bell tower in Lucca (Azzara  
197 et al. 2018a). The third frequency was also detected by the seismic stations in almost all records,  
198 while the fourth frequency only appears when the excitation level in the tower's structure was  
199 increased (it was detected in about the 30% of the records), and its values appear to be widely  
200 dispersed. A fifth frequency at about 5.7 Hz was also detected in about 30% of the records. With  
201 regard to the modal damping ratios, reported in Table 3, they are widely dispersed with variations  
202 on the order of hundreds of percentage points. Their values vary from 4% for the highest frequency,  
203 to 0.5% for the first. The values yielded by the seismic stations are generally higher than those from  
204 the accelerometers.

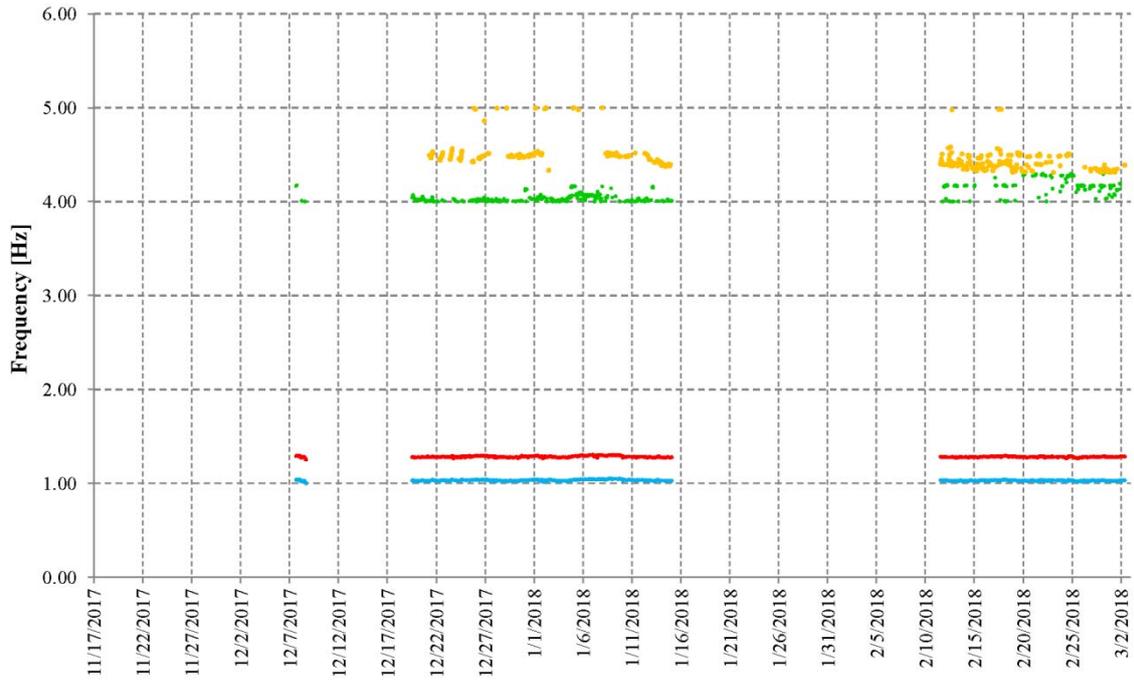
503 Figure 9. The tower's first four natural frequencies [Hz] detected by AGI accelerometers during the monitoring period.

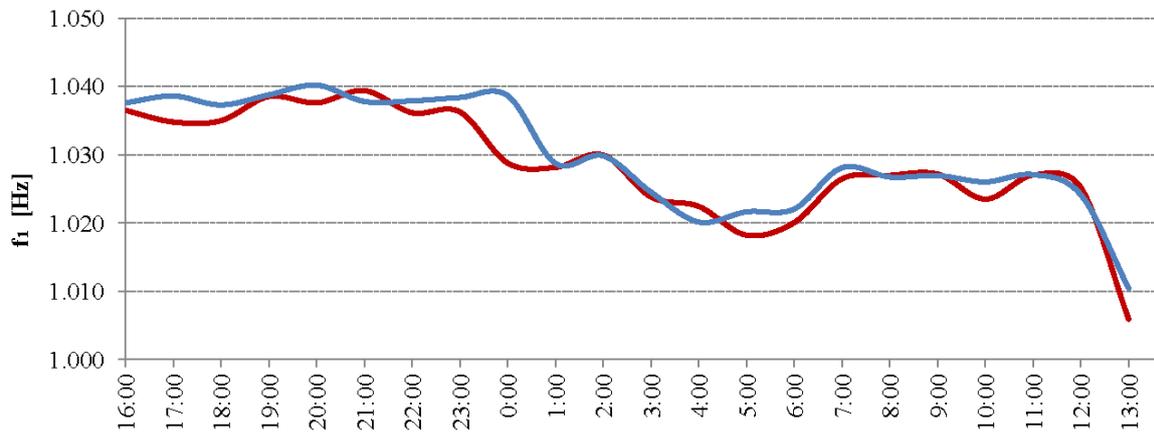
507 Figure 10. The tower's fundamental frequency obtained via AGI stations (blue) and SS20 stations (red) data from 7 to 8  
 508 December 2017 (respectively at 16:00 and 13:00).

206 Figures 10 and 11 show further comparisons of the results obtained via the two instruments. In  
207 particular, Figure 10 shows the trend of the tower's fundamental frequency from 7 to 8 December  
208 2017, extracted from the AGI (blue) and the SS20 (red) devices. The very good agreement between  
209 the two measurements indicates that the fluctuations exhibited in the frequency values do not  
210 depend on the instruments' functioning, but are rather due to environmental factors. Figure 11

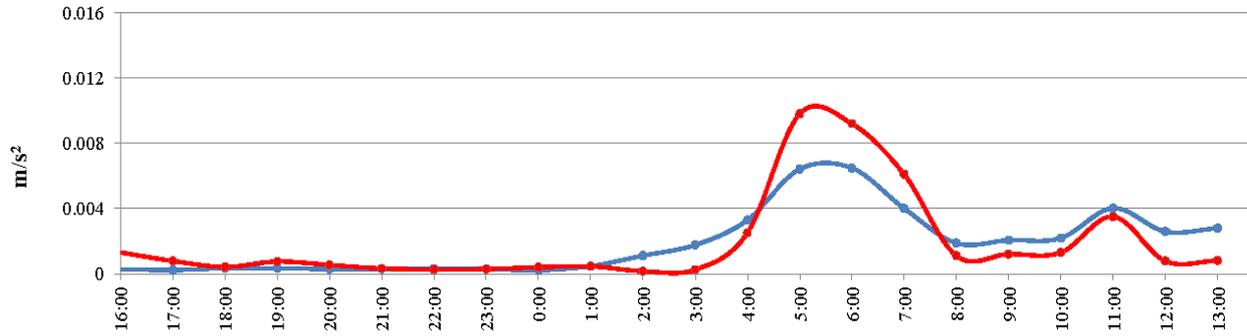
513 Figure 11. Maximum absolute accelerations along  $x$  recorded by the S.1 station (blue, +42 m) and the S. 945 station  
514 (red, +42 m) from 7 to 8 December 2017.

211 shows a comparison of the hourly maximum accelerations (absolute values) recorded by the  
212 instruments during that same period. It is worth noting that maxima in the acceleration values  
213 correspond to minima in the frequency values. In fact, a look at the weather those days revealed  
214 very bad conditions, with strong wind velocities (see also Figure 15), thereby suggesting a  
215 connection between the frequency reduction shown in Figure 10 and the action of the wind, which  
216 due to the masonry's inability to withstand large tensile stresses, tends to decrease the tower's  
217 stiffness (see also Figure 16).

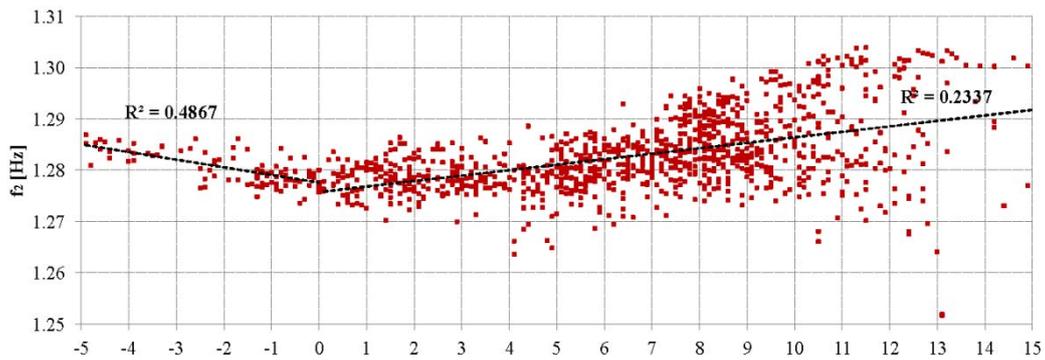
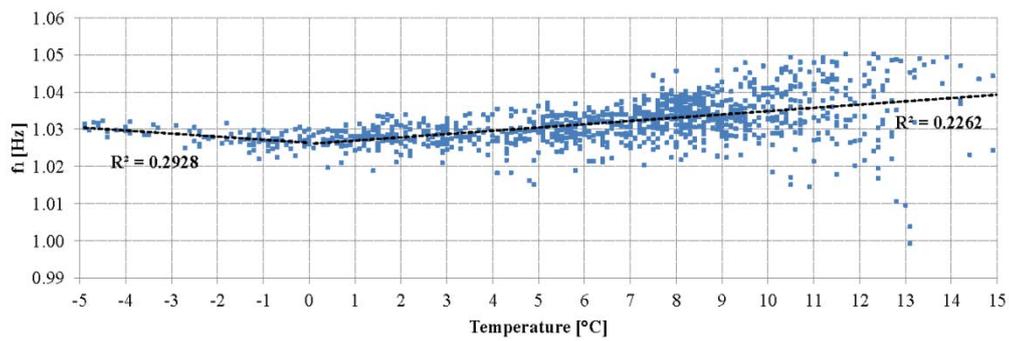
517 Figure 12. The first (blue) and second (red) natural frequencies of the tower [Hz] vs. temperature [°C].

220 With regard to the influence of temperature on the tower's dynamic behaviour, Figure 12 shows the  
221 correlation of the first two natural frequencies with air temperature, measured by a sensor located in  
222 the Lucca Botanical Gardens, in Lucca's historic centre. The figure confirms the findings of other  
223 long-term vibration monitoring campaigns on historical towers (Cabboi et al. 2017), (Ubertini et al.  
224 2017), including that carried out on the San Frediano bell tower in Lucca (Azzara et al. 2018a):  
225 frequencies tend to increase with temperature. This behaviour is confirmed from a numerical point  
226 of view, by the results described in (Girardi et al. 2017), which reports on a nonlinear FE analysis of  
227 the Clock Tower conducted by modelling the effects of the thermal variations on the structure's  
228 frequencies. The numerical simulation supports the hypothesis that an increase in temperature

229 induces a reduction in the fracture strains inside masonry, thus increasing the global stiffness of the  
230 structure.

231 With regard to negative temperature values, Figure 12 reveals opposite trend for frequencies, which  
232 turn out to increase when the temperature decreases. This phenomenon was mainly observed in the  
233 latter part of February 2018, when temperatures persistently decreased below zero, as highlighted  
234 by Figure 13. Correspondingly, the figure shows the change in the frequency trend. The behaviour  
235 below freezing has also been reported for similar weather conditions in (Ubertini et al. 2017) and  
236 (Cabboi et al. 2017), where the increasing of frequencies when temperature goes below zero is

237 ascribed to the fact that ice tends to close micro-cracks and then stiffen the masonry. It is also worth  
238 noting that, as long as the temperature remains above zero, frequencies respond to temperature  
239 variations with a phase shift in time, most likely connected to the thermal inertia of the tower,  
240 while, below zero, the frequency and temperature appear to be in phase.

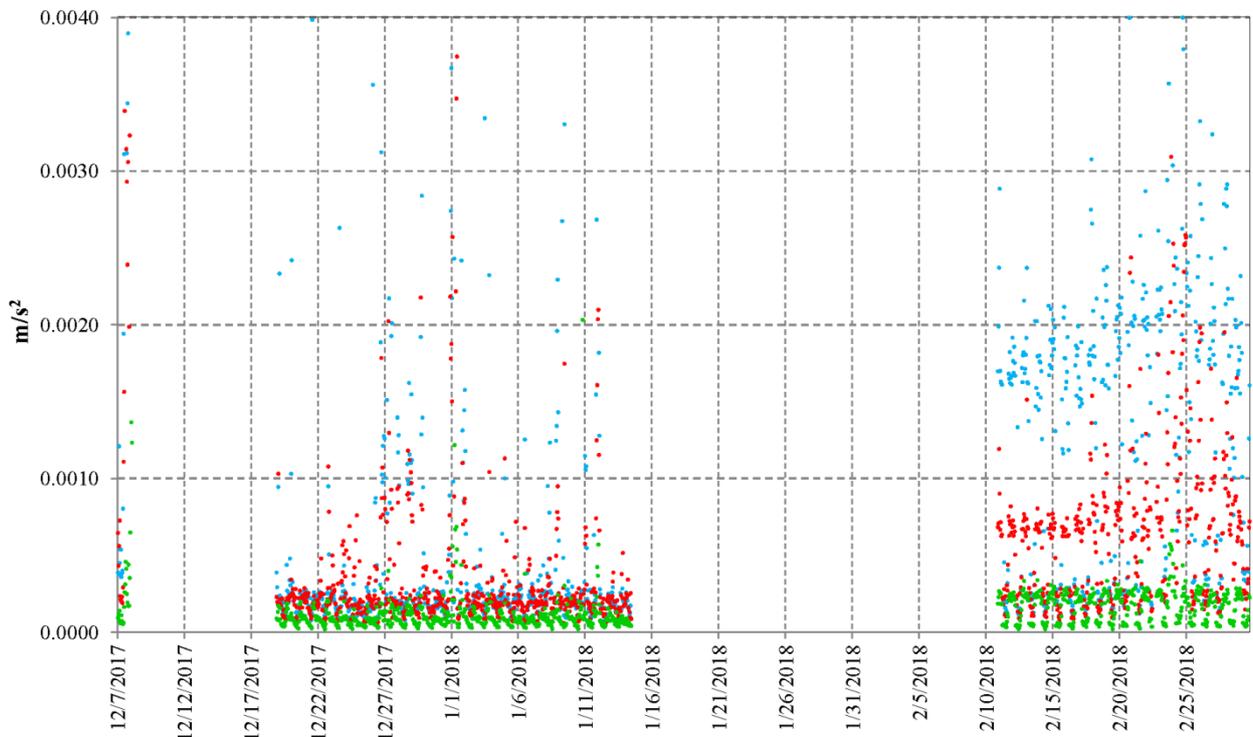
dots), y (red dots) and z (green dots) directions.

241 The trend over time of the maximum accelerations recorded by AGI sensors, after high-pass  
242 filtering of the signals (with cutoff frequency of 0.1 Hz), is shown in Figure 14. The vibration level  
243 in the tower is very low, generally under  $2 \cdot 10^{-3} \text{ m/s}^2$ , thanks to restrictions to vehicular traffic in  
244 force in the Lucca historic centre. The figure highlights an increase in the tower's vibration level  
245 during the Christmas holiday period (from 22 December to 1 January), connected to the increased  
246 pedestrian traffic in the historic centre, with a peak on New Year's Day. The figure also reveals a  
247 systematic increase in the accelerations, on average of one order of magnitude, from 9 February  
248 onward. This is due to the ringing of the tower bells, which had been suspended for restoration of  
249 the ancient clock and was restarted on 16 January 2018. The bell system is composed of three

250 bronze bells, fixed at their supports and rung by hammers each quarter an hour in the  $x$  direction  
251 (along Via Fillungo). Indeed, Figure 14 shows significant amplification along  $x$  (blue dots).

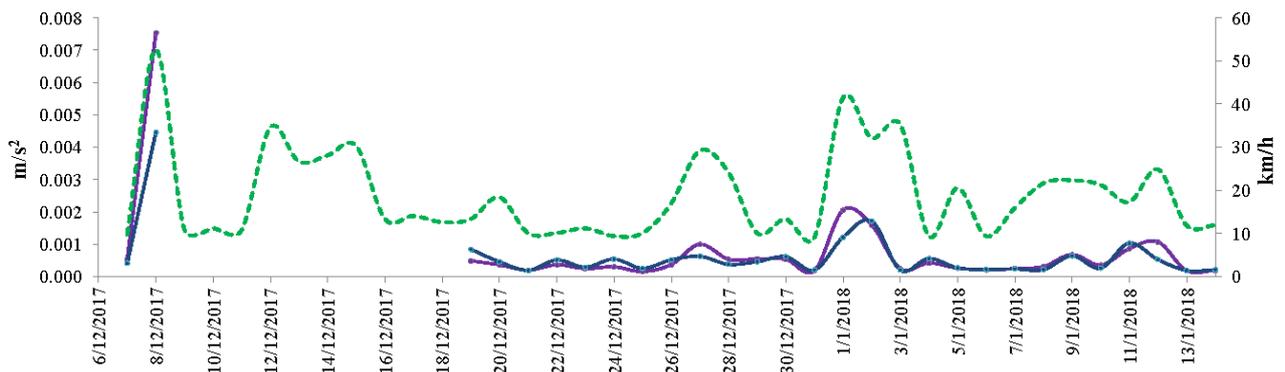
525 Figure 15. Daily average of the maximum hourly accelerations measured by S.2 vs. time along the x (blue) and y (red).  
 526 directions. The dashed green line stands for the daily maximum wind speed. The correlation coefficients are  $R^2=0.5654$   
 527 (daily average x – wind speed) and  $R^2=0.5018$  (daily average y – wind speed).

252 With regard to the environmental parameters that could influence the acceleration levels on the  
253 tower, Figure 15 plots the daily average values of the maximum hourly accelerations in the  $x$  (blue)  
254 and  $y$  (red) directions, for about a month, together with the daily maximum wind speed recorded at  
255 Pieve di Compito, about 10 km from the Lucca historic centre (data available at  
256 [www.sir.toscana.it](http://www.sir.toscana.it)). The figure clearly shows a correspondence between the peaks in the  
257 acceleration levels and those in the wind speed.

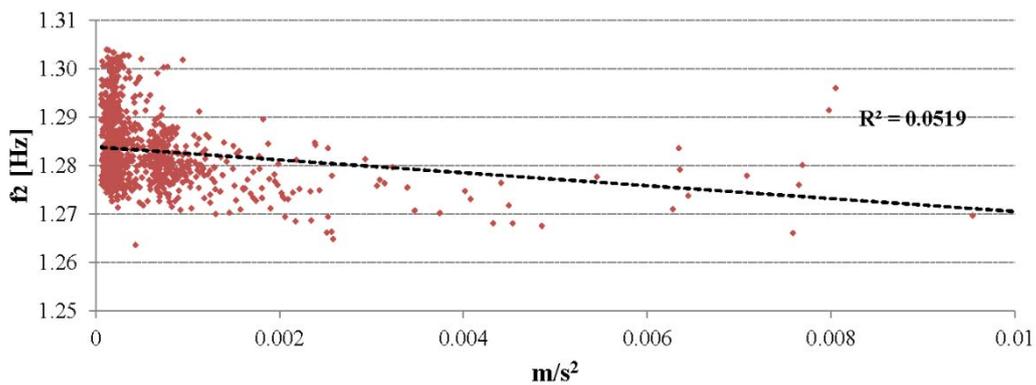
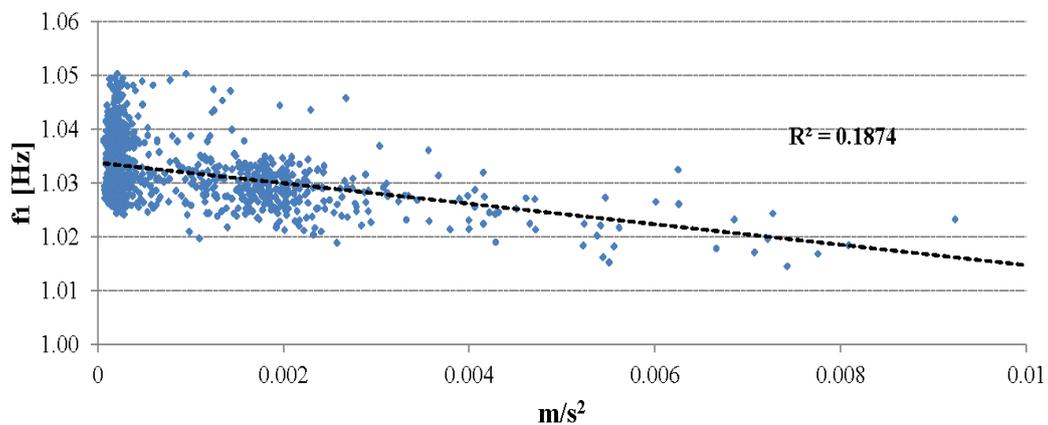
530 Figure 16. The first (blue) and second (red) natural frequencies of the tower [Hz] vs. the maximum acceleration  
 531 experimented by the tower [ $m/s^2$ ]

258 Figure 16 reports the correlation between the maximum acceleration experimented by the tower and  
259 its natural frequencies and shows that frequencies tend to decrease as the amplitude of acceleration  
260 increases. This trend is not unexpected and can be attributed to masonry inability to withstand

261 tensile stresses. Similar results for masonry-like materials are obtained via analytical models in  
262 (Girardi and Lucchesi 2010).

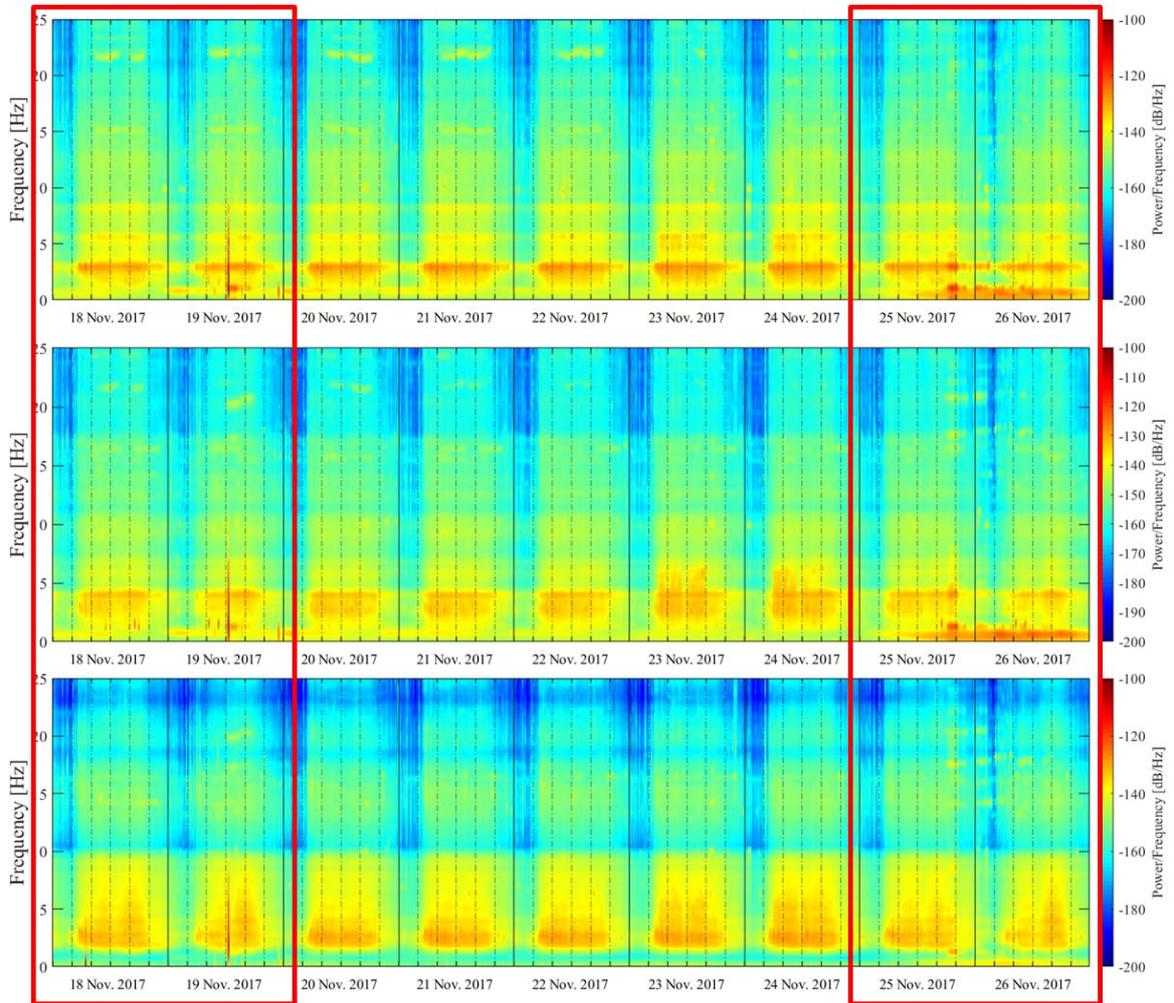
535 Figure 17. Spectrogram of the signal recorded by S.942 (+ 0,00 m) in the x (up), y and z (bottom) directions from 18 to

536 26 November 2017. Week-ends are highlighted by the red boxes.

264 Figures 17 and 18 provide information on the tower' vibrations over time in the band [0, 25] Hz. In  
265 particular, Figure 17 shows the spectrogram of the signal recorded by S.942, at the base of the  
266 tower, in the period 18 November to 26 November 2017, for the three channels  $x$  (up),  $y$  and  $z$   
267 (bottom). The tower's natural frequencies are clearly visible in the band [0, 10] Hz (horizontal  
268 lines), as well as the 3 Hz frequency of the building adjacent to the tower, along the  $x$  direction. As  
269 a result of anthropogenic activity, the power frequency increases in the entire band during the  
270 daytime, in particular during week-ends (18-19 November, 25-26 November). The three-  
271 dimensional spectrogram of channel  $x$  plotted in Figure 18 also highlights other anthropogenic  
272 activity between 20 and 25 Hz, which could be attributed to traffic in the historic centre. At about

273 12:30 (UTC) on 19 November, there is a clear frequency peak, which can be attributed to the M4.4  
274 Parma earthquake reported in Table 4.

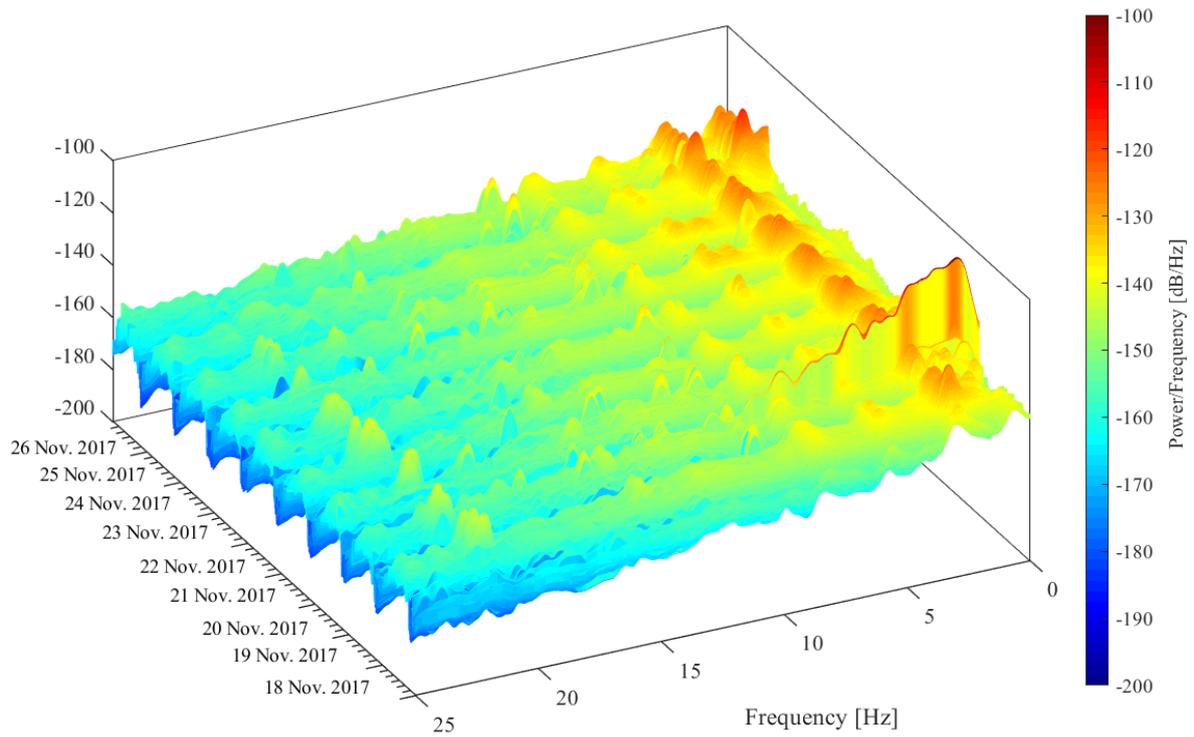
539 Figure 18. Three-dimensional spectrogram of the signal recorded by S.942 (+0,00 m) in the x direction from 18 to 26  
 540 November 2017.

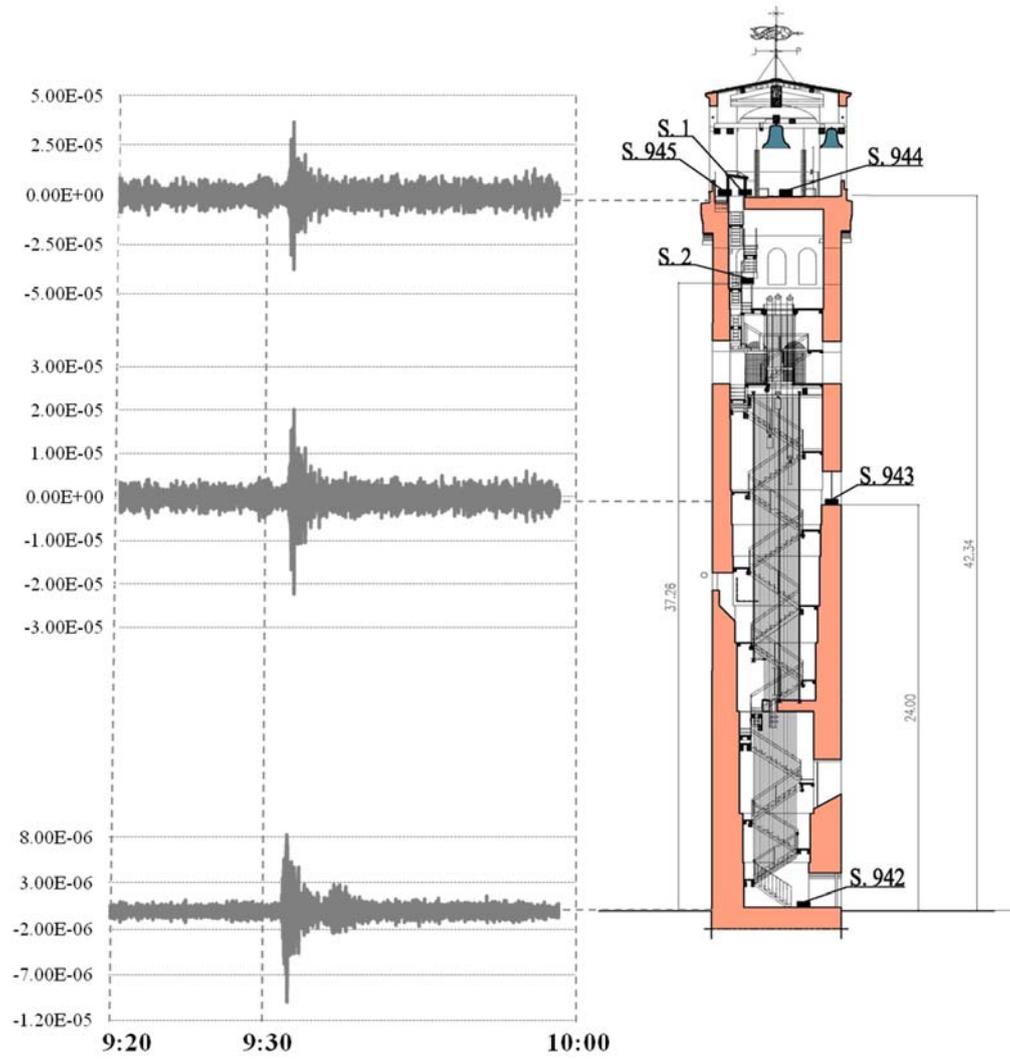
542 Figure 19. Signal of the Peru earthquake recorded on the tower in the  $x$  direction by S.942, S.943, S.944 on 14 January

543 2018 from 9:33 (UTC) onward. Signal amplitude is in  $m/s^2$ .

275 Many seismic events have been detected on the tower during the monitoring period. Table 4 shows  
276 the main earthquakes recorded, while Table 5 reports the teleseismic events identified in the signals.  
277 Figure 19 shows the teleseismic record of the Peru earthquake, which occurred at 09:18.44 (UTC)  
278 with a magnitude of 7.1, and was recorded at about 09:33 (UTC) by the instruments on the tower. In  
279 particular, the figure shows the signals recorded by the SS20 seismic stations at different levels  
280 along the tower's height in the  $x$  direction. The same event was also recorded by the S.2  
281 accelerometer. At such a considerable distance from the epicentre, the seismic signal loses its high  
282 frequency content and becomes recognizable only at low frequencies. The records in the Figure  
283 were obtained by filtering the signals via a Butterworth band-pass filter with lower cut-off

284 frequency of 0.04 Hz and a higher cut-off cut at 1 Hz. It is worth noting that after the first arrival of  
285 the waves the event remains clearly recognizable in the signals for long time.

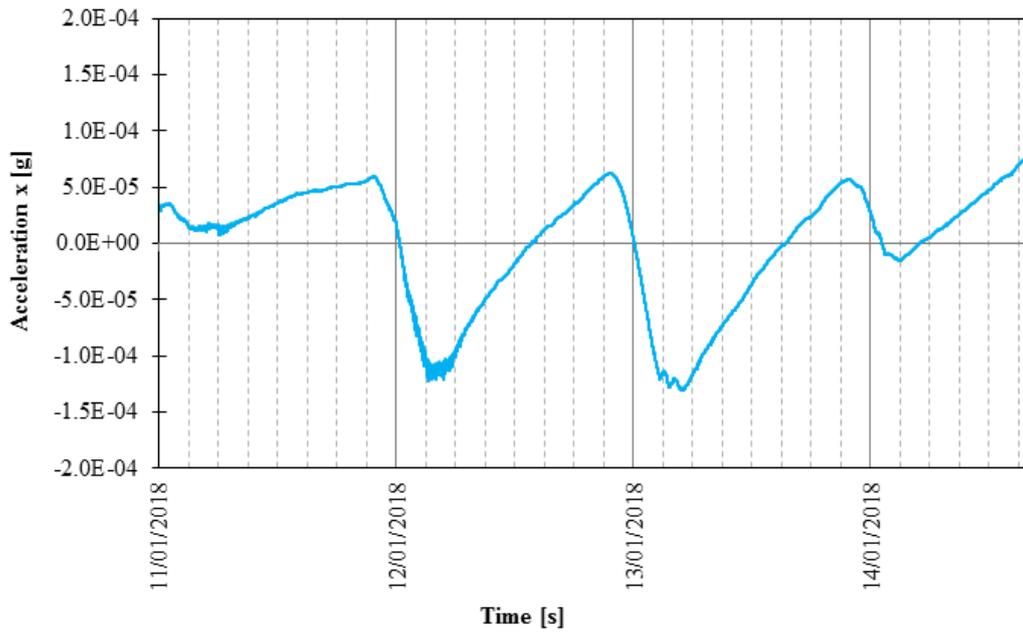
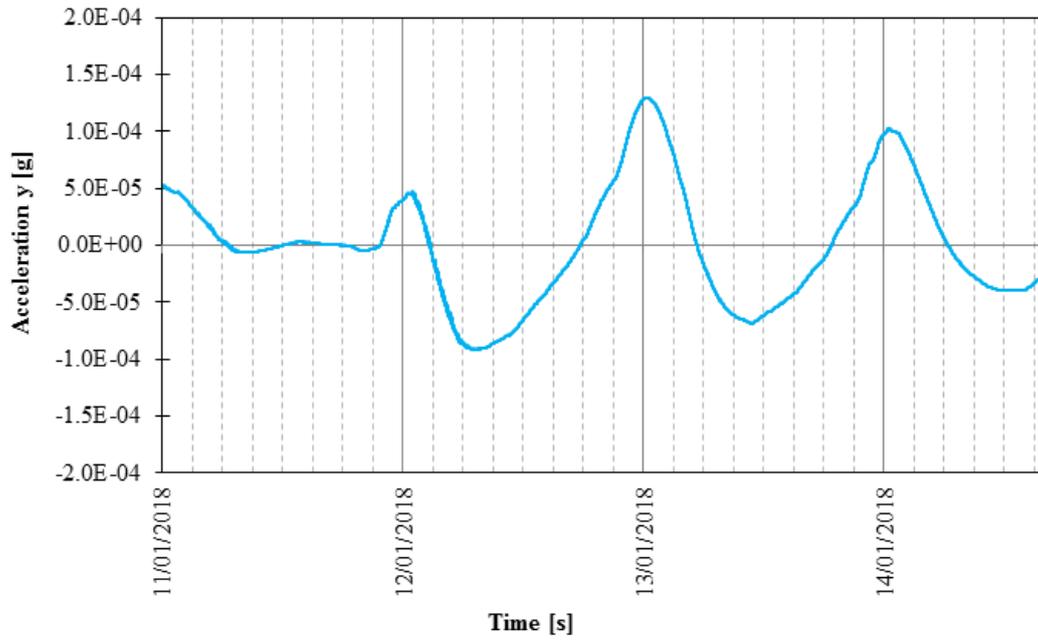
546 Figure 20. Low-pass filtered accelerations recorded by S.2 along the  $x$  and  $y$  (bottom) directions from 11 to 14 January

547 2018.

286 Analyzing the low frequency content of the recorded signals can provide further information on  
287 movements of the tower. Figure 20 shows the signals recorded by the S.2 accelerometer from 11 to  
288 14 January 2018 along the  $x$  (up) and  $y$  (bottom) directions. The signals in the figure were low-pass  
289 filtered with a cut-off frequency of 0.5 Hz, and clearly reveal a slow oscillation with period of about  
290 24 hours. The same oscillations can be detected in the temperature signal (Figure 21) measured by  
291 the sensor inside the instrument. The temperature signal is however not in phase with the  
292 accelerations, thus demonstrating that the oscillations of the accelerometric signal are not a direct  
293 effect of temperature on the instrument. It is also worth noting that the signals along the  $x$  (North-  
294 South direction) and  $y$  (East-West direction) directions present a phase shift of 3 to 6 hours, and the

295  $y$  signal is delayed with respect to that along  $x$ . A possible interpretation of these oscillations lies in  
296 the daily temperature variations caused by exposure of the tower to the sun. As the exposure of the  
297 façades changes during the day, the tower appears to twist as shown in the figures. A measure of the  
298 displacements induced by this effect at the top of the tower can be easily obtained from the figures.  
299 In fact, for small oscillations, the modulus of the horizontal acceleration expressed in  $g$  coincides  
300 with the inclination angle of the tower in radians. Thus, taking into account the actual position of  
301 the instrument (at +37 m), horizontal displacements turn out to be on the order of 3-4 mm for both  
302 directions. These low-frequency displacements seem to be the main components of the total  
303 horizontal displacements experienced by the tower in normal conditions (i.e. in the absence of

304 earthquakes or other strong dynamic actions). In any case, this data should be complemented by  
305 further measurements at the ground and static measurements as well.

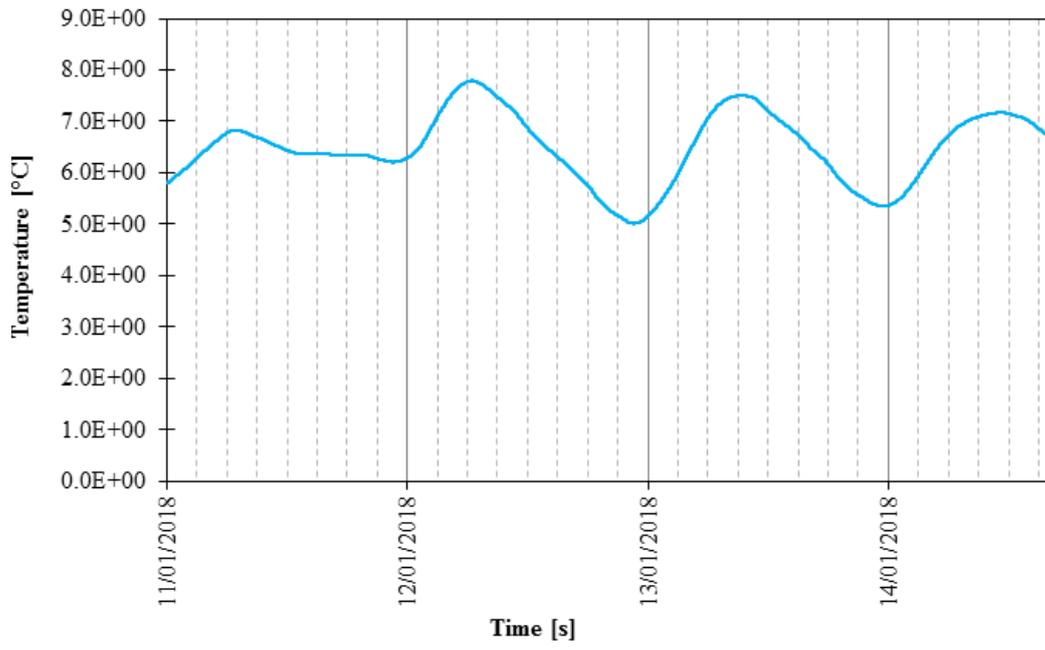
550 Figure 21. Temperatures recorded by the sensor installed inside S.2 from 11 to 14 January 2018.
