Contribution Title: Exploring UAVs for Structural Health Monitoring

Author/ author affiliation/ author email: Danila Germanese, Davide Moroni, Maria Antonietta Pascali, Marco Tampucci / Institute of Information Science and Technologies, National Research Council of Italy, Pisa, Italy / {name.surname}@isti.cnr.it; Andrea Berton / Institute of Geosciences and Earth Resources (IGG), National Research Council of Italy, Pisa, Italy / andrea.berton@igg.cnr.it

Conference Special Session: Aerial, Ground and Underwater Robotics for Cultural Heritage

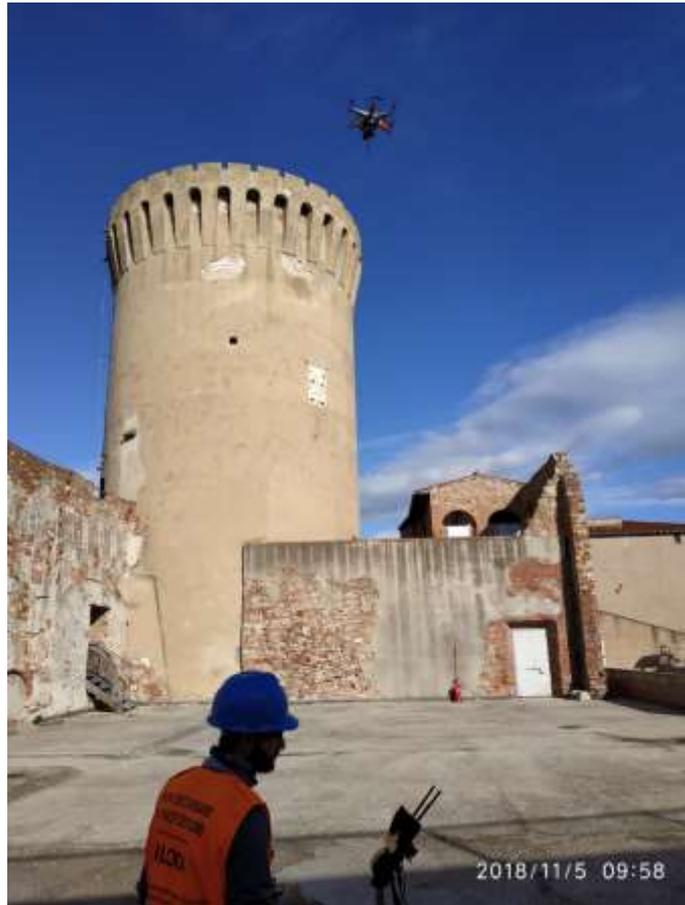
Fig. 2 – The operator pilots the UAV around Mastio di Matilde, a tower in the Fortezza Vecchia complex in Leghorn, which has been considered as a case study in the framework of the Moscardo project.

Indeed, in the San Gimignano case, the UAV has been relevant for photogrammetric reconstruction and visual inspection of the towers and surrounding structures which are very difficult to be reached and inspected by other means. The second case study of the Fortezza Vecchia has an additional interesting feature: it presents several critical crack patterns. Since the sea partially surrounds such a Tuscan historical building, monitoring its ancient walls is very hard by manual methods. Besides, the sides of most of the cracks along the fortress walls are quite far from each other and don't lie on the same plane. Therefore, using standard methods (e.g. those based on planar crack gauges) may not allow for obtaining an absolute and accurate measurement of the separation of the sides. With the aim to monitor such complex crack patterns over time, an ad hoc image processing pipeline has been identified and tested in a controlled environment (Germanese et al 2018a) and then applied for long-term monitoring on-site (Germanese et al 2019), where measurements accuracies are reported. In brief, the proposed method is a marked-based approach for extracting quantitative information about the absolute value and displacement over time of a set of predefined targets around a crack pattern to be studied. In this way, for instance, a crack enlargement can be detected as well as shear displacements.

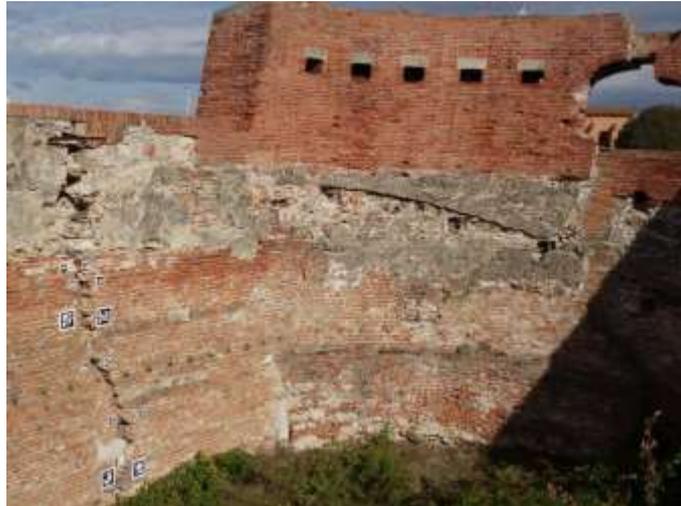
Fig. 3 – Bastione della Capitana. This area of the Fortezza Vecchia complex has been considered for long-term monitoring of cracks and damages in the building by UAV inspection. A configuration of markers has been placed around a crack to perform quantitative 3D measurements.

At first, under the suggestion and guidance of an expert such as a civil engineer or architect, a configuration of planar markers is installed around the crack pattern or damage to be monitored. Notice that this is the only step, which, at the moment, requires physical access to the damaged part, while the actual monitoring can be executed remotely, thanks to the use of the UAV.

At each inspection time, either following a predefined mission or in manual flight mode, the UAV can reach waypoints nearby a crack and capture a set of pictures using a standard camera (in our case, an RGB camera). Collected images are then transmitted to the service layer and there processed for extraction of a matrix of distances among the various planar markers as well as their orientation. Tests have allowed demonstrating that the results are reproducible. A UAV can obtain that acceptable images under normal operating conditions (no further requirements on wind speed and weather have been required) during daylight. It has been possible to perform routine analysis of cracks and to understand possible seasonal changes in a way that is safe for operators since it is not required to reach damaged and critical areas. Further capabilities of the UAVs might be considered in the future, such as adding infrared vision to analyse defects and other onboard intelligent systems to detect faults (Jalil et al, 2019).

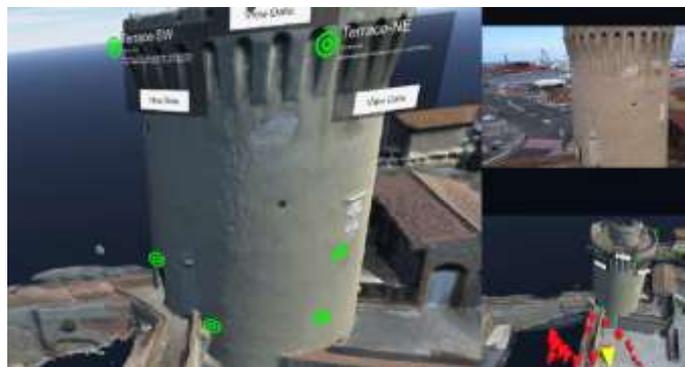
Fig. 4 – The VR interface is composed of three elements: (i) the central part shows a reconstructed virtual scene with installed sensors and their gathered values; (ii) on the upper right side of the screen, the video recorded by the UAV during the inspection operations is shown; (iii) in the lower right side, a panoramic view of the virtual scene is displayed reporting also UAV actual position (yellow pyramid) and travelled path (represented as a set of smaller red pyramids). Please, see <http://moscardo.isti.cnr.it/> for an interactive demo.

The VR system can be experienced in several ways: (i) freely exploring it and interacting with displayed sensors; (ii) accessing past UAV inspections and retracing UAV flights performed during a selected inspection; (iii) live during a UAV inspection by following live movements. During the UAV flight, the user has no control of camera movement and orientation; indeed, camera movements reproduce actual UAV movements estimated using SLAM algorithm ORB-SLAM (Mur-Artal et al, 2015). Thanks to this solution and the high fidelity of the 3D model, UAV operators can rely on this tool to plan the drone's route and have a quick look at the sensor position relative to the UAV and possible obstacles surrounding the vehicle. In this modality, the interface is composed of three parts:

- The central and main one is devoted to showing the subjective 3D scene from the vehicle. From here, it is possible to view near sensors and acquired measurements;
- The upper right side displays the direct view of the UAV acquired by the onboard camera;
- The lower right portion shows a perspective view of the entire scene with the actual position of the UAV.
