LONG-TERM MONITORING OF A MASONRY TOWER WITH WIRELESS ACCELEROMETERS

Abstract

2 THE MATILDE TOWER

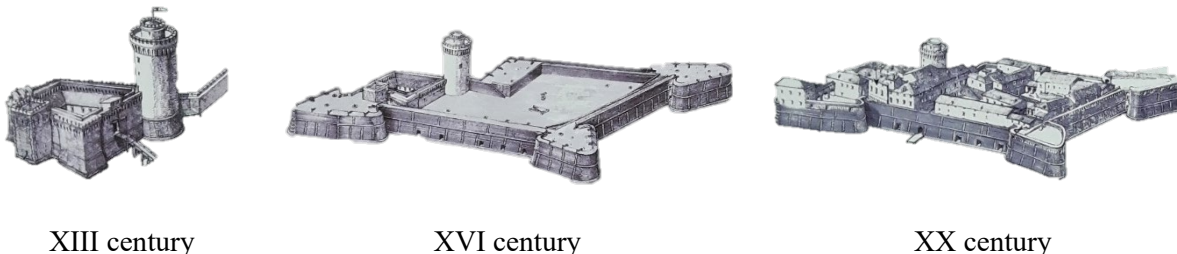
Figure 1: The evolution of the buildings around the tower over the centuries.

The structure underwent several modifications over the centuries, as showed in Figure 1. In the XIII century, the tower was part of a minor, squared fortification under the control of the

Pisa Republic. Then, under the Medici's domain, the defensive structure was further enhanced to a larger fortress with three bastions ("Ampolletta", "Canaviglia" and "Capitana") and two main gates by Antonio da Sangallo the Elder and Antonio da Sangallo the Younger. Lately, the structure was converted into a palace by Cosimo I de' Medici, and in the XX century, the fort became a prison. During the WWII, the complex sustained extensive damage, and most of the buildings were destroyed apart from the Matilde tower.
